Earthcents Home Energy Audit

Property Address:
123 Easy Street
Atlanta GA 30316

Date: 6/12/2015	Time: 09:00 AM	Report ID: Fake Customer 1
Property: 123 Easy Street Atlanta GA 30316	Customer: Mr. John Doe

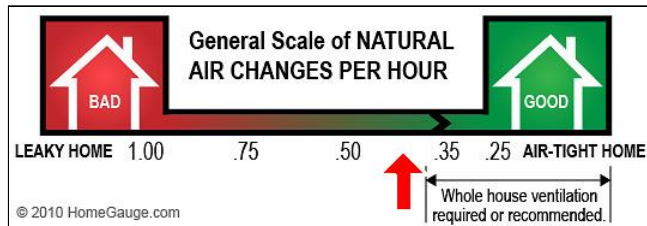
Your home tested at .41 ACH which is just 17% higher than an optimal reading. (Picture 2) **Your home is in the rare situation we encounter where your house is already fairly tight. The ACH reading does still indicate that some heating and AC is being lost through leaks in the building thermal envelope. Addressing the deficiencies identified in Items 1.2 through 1.10 will improve temperature consistency in the home and decrease heating and cooling costs.**

1.1 Picture 2 The ACH of your home

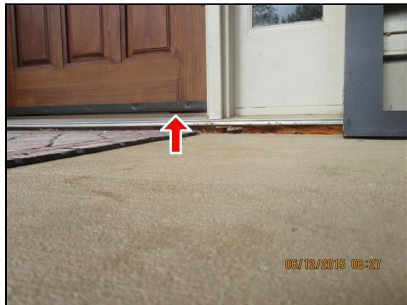
(1) The front door weatherstripping is in poor shape and the door fins are old/worn out.(Picture 1)
(Picture 2)

1.2 Picture 1 Worn out door fins on front door

We recommend replacing all damaged/compressed weatherstripping in conjunction with U-channels or door sweeps at the bottom of each of the doors. We also recommend adjusting the strikeplates (and installing strikeplates, where missing) to ensure a tight door seal.

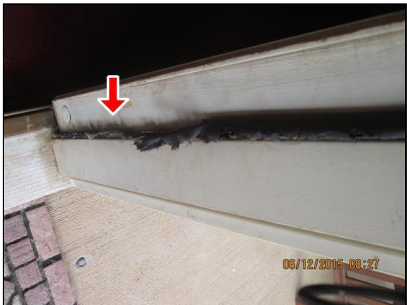
1.2 Picture 2 Front door weatherstripping is in very poor shape

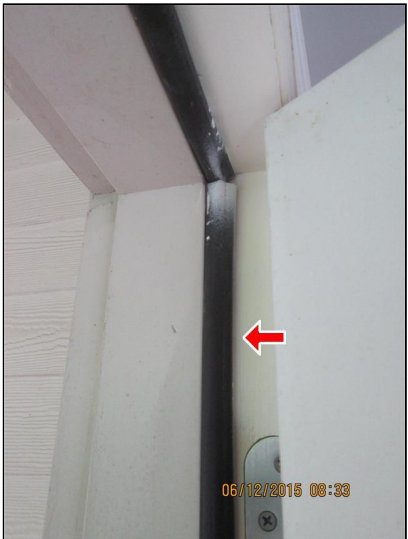
The kitchen and double door weatherstripping is compressed. The door fins are old/worn out and the deadbolt is loose due to no strikeplate. Each of these deficiencies all contributing to a poor air seal.
(Picture 3) (Picture 4) (Picture 5) (Picture 6)

1.2 Picture 3 Kitchen double doors have compressed weatherstripping

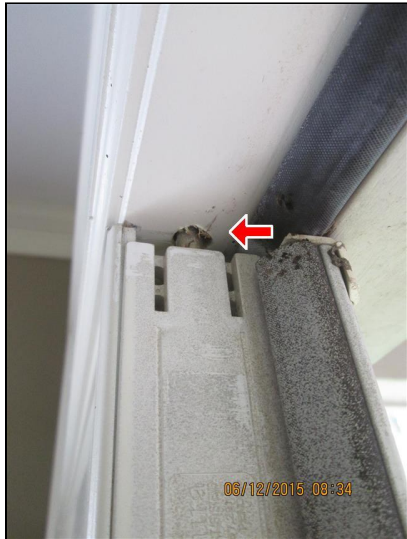
1.2 Picture 4 No strikeplate for double door deadbolt

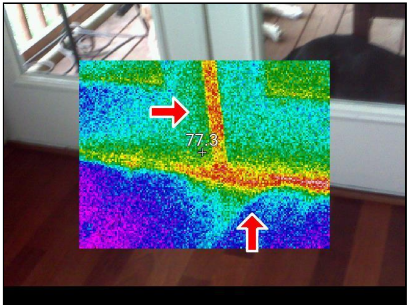
1.2 Picture 5 Failing door fins and weatherstripping on kitchen double doors

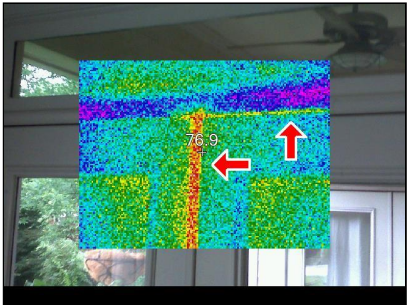
1.2 Picture 6 T-bar weatherstripping and top of double doors showing significant air leakage

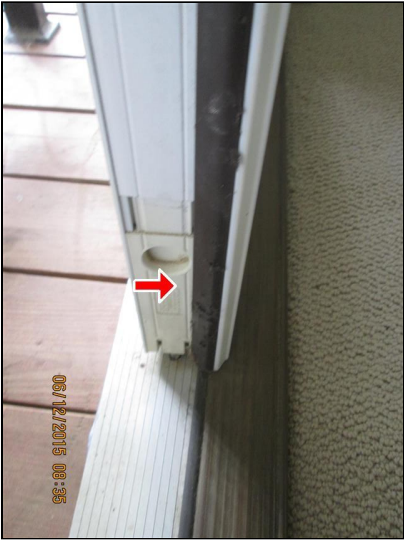
The master bedroom double doors have chewed up weatherstripping allowing for easy air infiltrations.(Picture 7)

1.2 Picture 7 Chewed up weatherstripping on master bedroom double doors

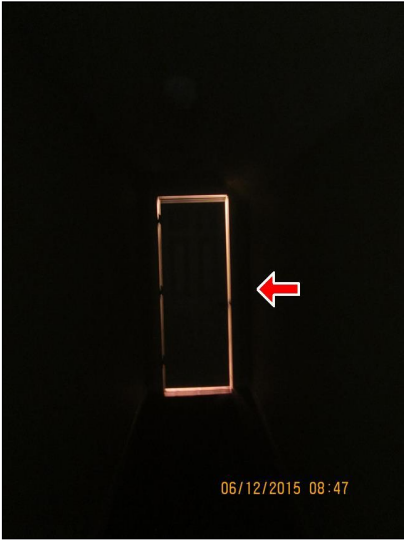
The basement door has no air sealing measures in place easily allowing unconditioned crawlspace air into the conditioned basement.(Picture 8)

1.2 Picture 8 Portal to another dimension, or unsealed basement door to mechanical room

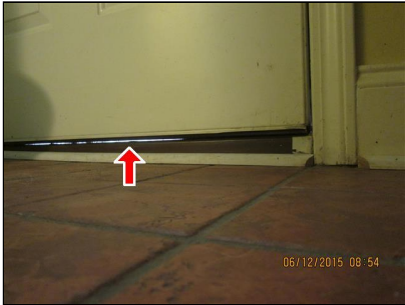
1.2 Picture 9 Daylight visible under basement exterior door

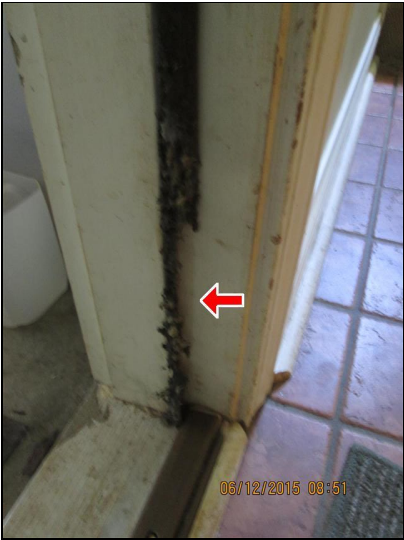
(2) The door to the garage is leaky due to chewed up weatherstripping and unsealed interior trim.(Picture 10) (Picture 11) (Picture 12)

Garages are a source of hazardous gases such as Carbon Monoxide (CO). Air exchange between the conditioned living space and the garage is therefore considered a health and safety issue. Additional safety item relating to air exchange with the garage is covered in section 1.4(2) and 1.14.

1.2 Picture 10 Garage door weatherstripping in very poor condition

We highly recommend replacing all damaged/compressed weatherstripping, installing a U-channel or door sweep at the bottom of the door and adjusting the strikeplate to ensure a tight door seal.

We also highly recommend installing a CO monitor near to this door.

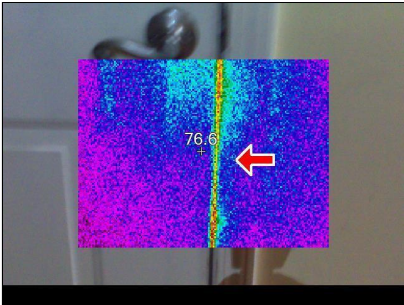
1.2 Picture 11 Leaky door to garage

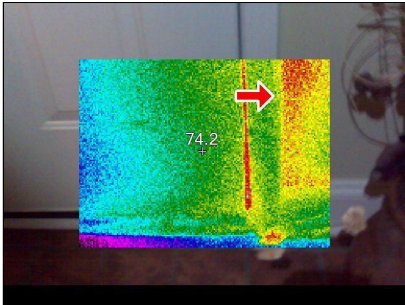
1.2 Picture 12 Significant air exchange between garage and conditioned living space via interior door trim

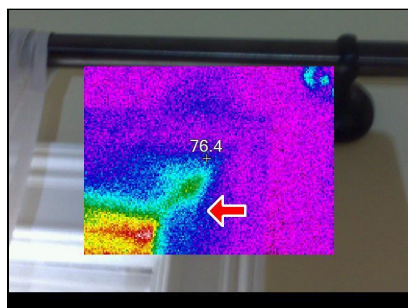
However, interior trim around the 1st floor bedroom windows are a source of air exchange throughout the home, allowing valuable conditioned air to escape from the building envelope and in turn increasing heating and cooling costs.(Picture 1) (Picture 2) (Picture 3)

1.3 Picture 1 Interior window trim air leakage

We recommend air sealing all interior window trim in the 1st floor bedrooms with clear silicone caulk.

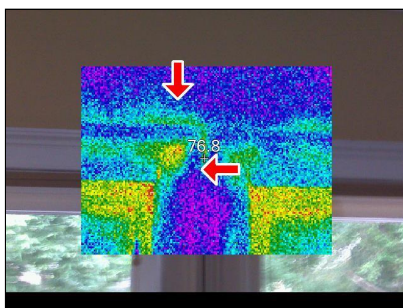
1.3 Picture 2 Interior window trim air leakage in master bedroom

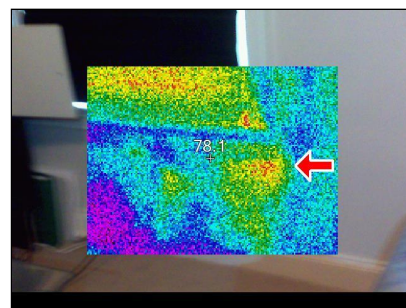
1.3 Picture 3 Interior trim air leakage from bedroom window

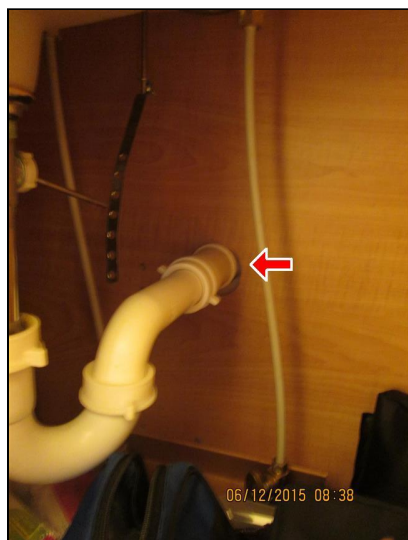
(1) Plumbing penetrations throughout the home were not sealed and thermal imaging revealed them to be leaky.(Picture 1) (Picture 2)

1.4 Picture 1 Unsealed plumbing penetration in the master bathroom

We recommend sealing all plumbing penetrations with either expanding foam or clear silicone caulk.

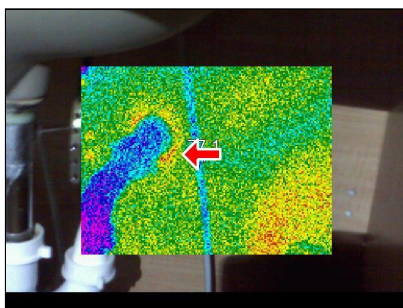
1.4 Picture 2 Air exchange through unsealed plumbing penetration

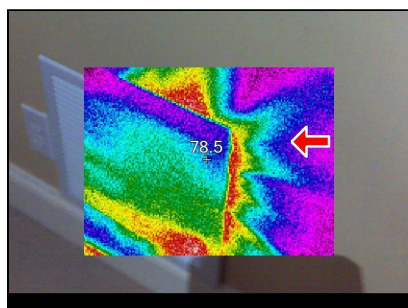
(2) The plumbing access panel in the master bedroom is allowing significant air exchange. (Picture 3)
The floor of the bath and master bedroom is shared with the garage.

Garages are a source of hazardous gases such as Carbon Monoxide (CO). Air exchange between the conditioned living space and the garage is therefore considered a health and safety issue.

1.4 Picture 3 Significant air exchange via plumbing access panel

A lower cost option is to air seal the access panel by installing rigid foam board in the plumbing access aperture and air sealing the perimeter with silicone caulk or expanding foam.

We highly recommend installing a CO monitor near to this area.

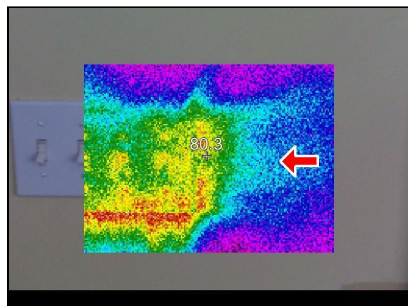
Leakage was detected from many of the electrical outlet and light switch penetrations throughout the home. (Picture 1) This is mainly attributed to the air exchange through the exterior wall cavities that is entering the home from around the electrical boxes.

1.5 Picture 1 Air leakage via wall switches and outlet boxes

We recommend installing insulating gaskets behind all outlet and switchplate covers along the exterior walls to help mitigate air exchange. This is inexpensive and easy to do. These gaskets can be purchased at most hardware stores, such as Lowe's or Home Depot.

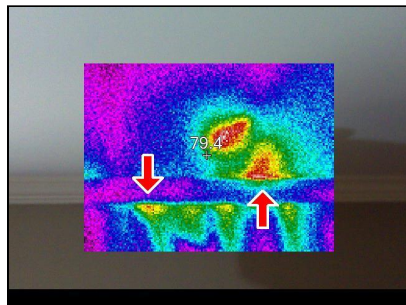
1.6 Picture 1 Significant air leakage through crown molding

We recommend that the crown molding in the master bedroom be sealed with clear silicone caulk.

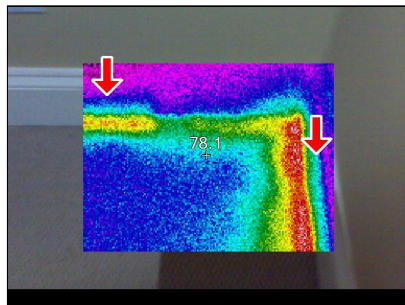
1.6 Picture 2 Leaky baseboards in the master bedroom

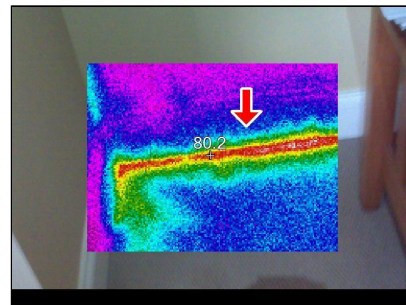
1.6 Picture 3 Significant air leakage from baseboards

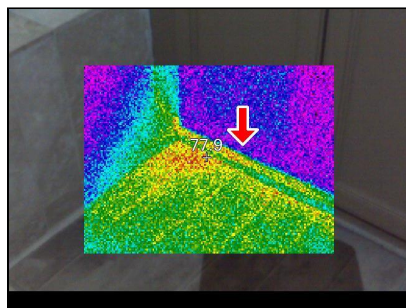
The baseboard trim beneath the master bathroom cabinets is also leaky. (Picture 4)

1.6 Picture 4 Air exchange from underneath master bathroom cabinets

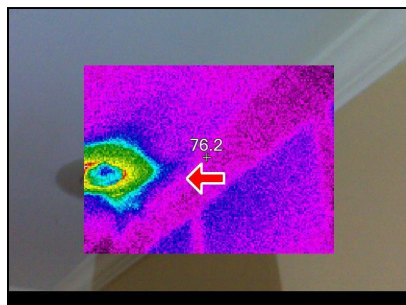
We counted 18 recessed lights in the ceiling of the main floor in your home. Thermal imaging revealed significant leakage through the hole surrounding the lights leading to the attic. (Picture 1)

1.7 Picture 1 Significant air leakage from recessed lighting

For your home, we recommend installing LED can light retrofit kits that come with a gasket to seal off the attic air from entering the home. This effectively kills 3 birds with one stone:

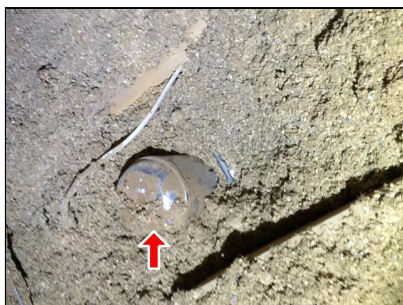
Additionally, safety measures were not taken when installing cellulose insulation in the attic - Cellulose insulation is in direct contact with non-IC Rated can lights, which is a fire hazard. Insulation has already melted to the exterior of the can lights.(Picture 2) (Picture 3)

1.7 Picture 2 Insulation touching non-IC Rated can lights is a fire hazard

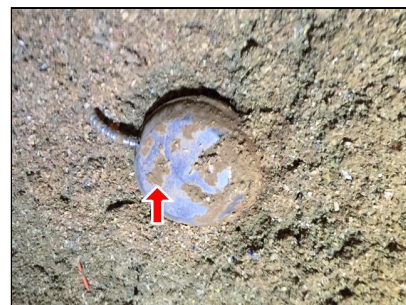
1.7 Picture 3 Cellulose attic insulation has melted to the can light

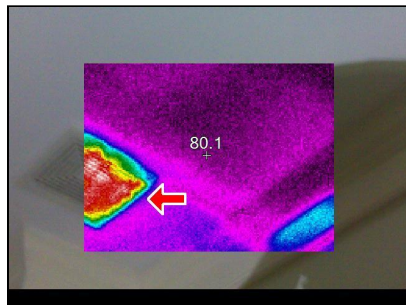
The bathroom ventilation fans on the 1st floor only vent near to the soffit and not to the exterior of the home. This allows an easy pathway for attic air to enter the home. Item 1(Picture) This also means that bathroom humidity is being vented into the attic space which can cause mold and/or insulation breakdown.

1.8 Picture 1 Free air exchange with the unconditioned attic via bath fan with no damper

We recommend venting both bath fans to the exterior via running bath fan ductwork to the soffit and installing exhaust dampers in the soffit that will close when the fan is not being used.

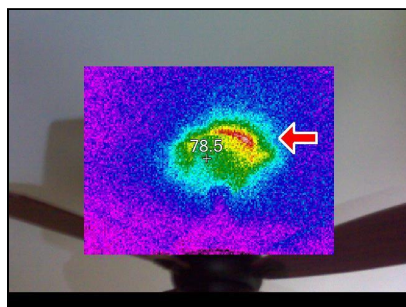
1.9 Picture 1 ceiling fan attic penetration

We recommend sealing all attic floor penetrations with caulk, backer board, or expanding foam and/or fire rated sealant.

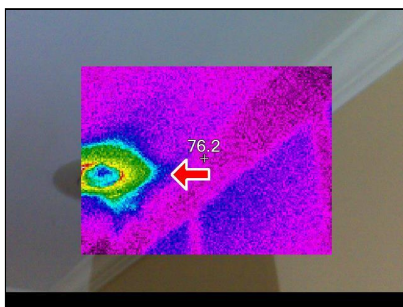
1.9 Picture 2 Recessed lighting allowing air exchange between attic and conditioned living space

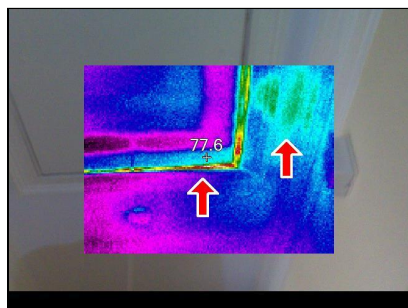
The attic access door tested as being very leaky. The trim around the attic access also has significant air exchange (Picture 1) (Picture 2) (Picture 3)

1.10 Picture 1 Significant air leakage from both unsealed attic access door and surrounding trim

We recommend installing a zip-up attic tent that is air sealed to the floor of that attic around the perimeter with expanding foam or caulk. We also recommend sealing the surrounding attic access trim with clear silicone caulk.

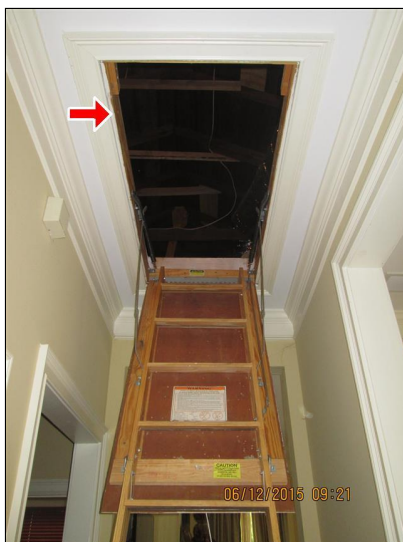
1.10 Picture 2 No air sealing measures present on attic access

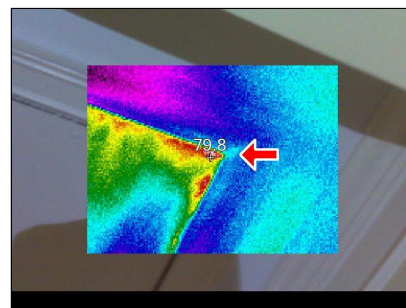
1.10 Picture 3 Air leakage from unsealed attic access

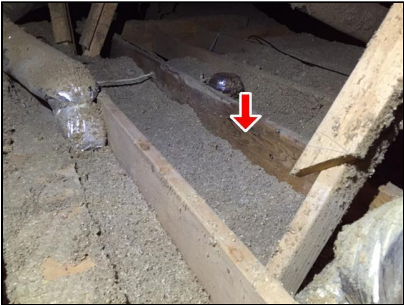
Attic insulation is extremely important in the north Georgia climate. Your attic has an average of only 3" of loose fill cellulose insulation (Picture 1) which is inconsistent and patchy throughout the attic which was very evident by thermal imaging. (Picture 2) (Picture 3) This equates to a resistance value of R-11. Current building code is R-30 and Southface Energy Institute recommends R-38 for our climate. This is a major deficiency and source of significant energy loss in your home.

1.11 Picture 1 Substandard levels of insulation in the attic

The best solution is to encapsulate the attic in 5.5" of open cell sprayfoam. This makes the attic a semi-conditioned space. This means the attic will no longer get extremely hot or cold. Sprayfoam is extremely effective insulation, does not deteriorate over time, and creates an air barrier between the living space in the house and the outside air. Encapsulating the attic with sprayfoam makes many of the air sealing measures addressed in this report unnecessary. Your 1st floor HVAC and ductwork system is located in the attic; encapsulating the attic will increase the efficiency and lifespan of this critical systems so that the HVAC unit doesn't have to work so hard to heat or cool your main floor.

Another option is to seal up all ceiling penetrations, insulate and air seal the kneewalls (see section 1.12) and install an additional R-30 blown cellulose or fiberglass insulation in the attic to increase resistance value to R-40+ throughout the attic floor.

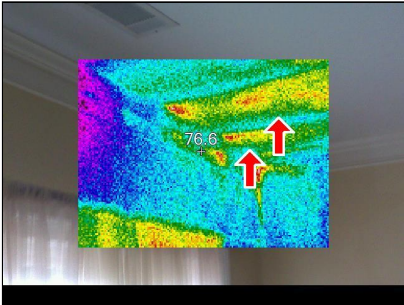
1.11 Picture 2 Attic insulation is patchy and completely missing in parts

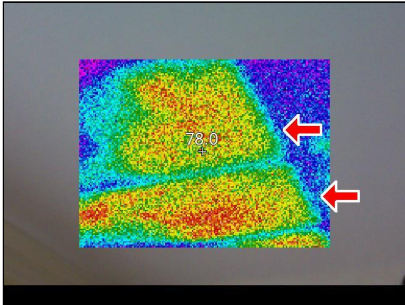
1.11 Picture 3 Area of missing attic insulation

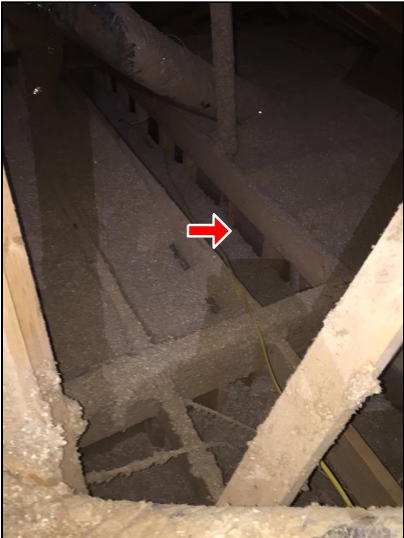
1.12 Picture 1 Zero insulation on attic kneewall above master bedroom

The best solution is to install fiberglass batt insulation over the vertical walls and sheath over them with poly-ISO insulation board with radiant barrier facing. All contact points should be sealed with expanding foam and foil tape to create a continuous air barrier between the conditioned space in the home and the unconditioned attic space.

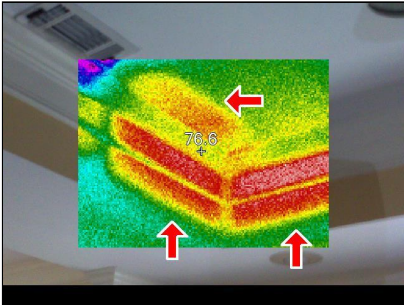
1.12 Picture 2 A substandard thermal barrier is a major cause of uncomfortable temperatures within the home

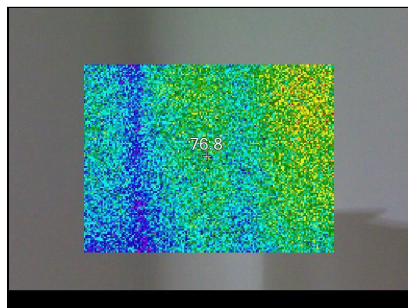
Thermal scans of the walls showed adequate wall insulation for north Georgia's climate. (Picture 1)

1.13 Picture 1 Adequate wall insulation

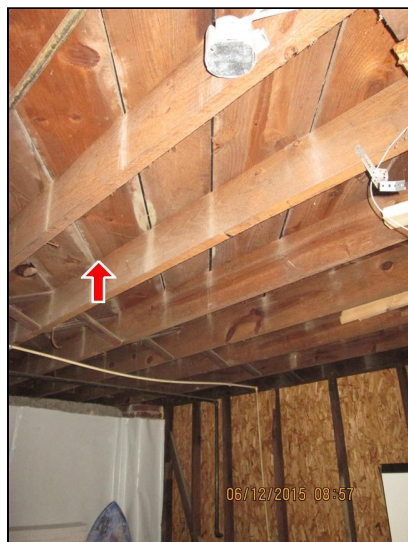
Poor or missing subfloor insulation is not a problem in the summer when the area stays relatively cool. However, in the cold winter months, this deficiency results in cold air, odors, and pests coming up into the conditioned areas of your home from the unconditioned crawlspace.

1.14 Picture 1 Zero subfloor insulation in unconditioned crawlspace

A lower cost option is to install R-13 fiberglass, suspended with sprung-metal rods, however batt insulation along the subfloor often fails by falling down with the effects of moisture and gravity over time.

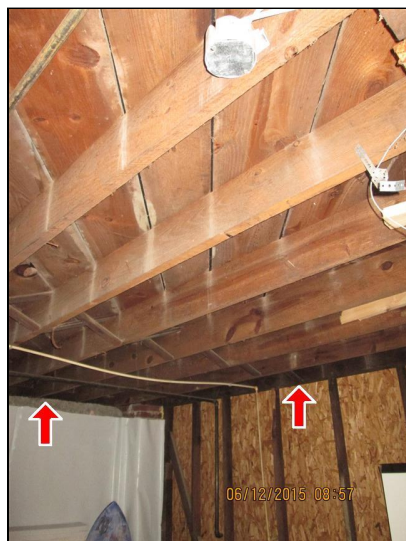
The rim joist in the crawlspace and conditioned basement storage room is not insulated. (Picture 1) (Picture 2)

1.15 Picture 1 Zero rim joist insulation

The best solution is to install 2" of closed cell sprayfoam insulation along the top of the rim joist to seal off the wall cavities from below.

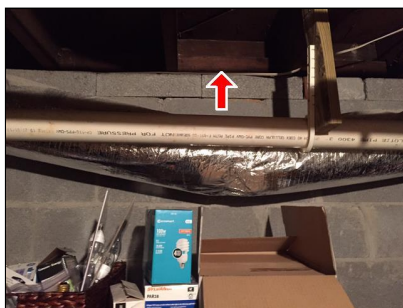
1.15 Picture 2 No insulation of rim joist

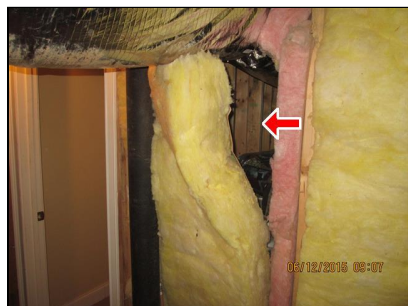
The basement kneewall area separates the conditioned basement from the unconditioned crawlspace. A large section of this kneewall is comprised of studs and batt insulation only. This is a thermal barrier,

however it is not an air barrier (Picture 1)(Picture 2) and effectively makes the unconditioned crawlspace unintentionally a semi-conditioned space. You mentioned that the previous homeowner left basement renovation incomplete including this area. You were right and this incomplete work is contributing to your high heating and cooling costs.

1.16 Picture 1 No air barrier present, meaning air can freely pass between unconditioned crawlspace and conditioned basement

We highly recommend completing the installation of this wall by installing drywall and baseboards. This would separate the 2 areas and stop the costly heating and cooling of the unconditioned crawlspace.

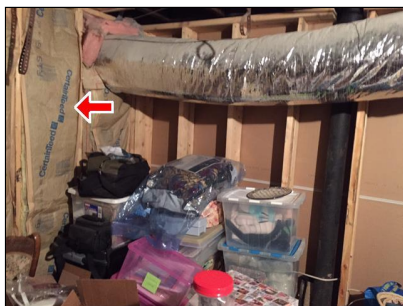
1.16 Picture 2 Batt insulation is an ineffective air barrier

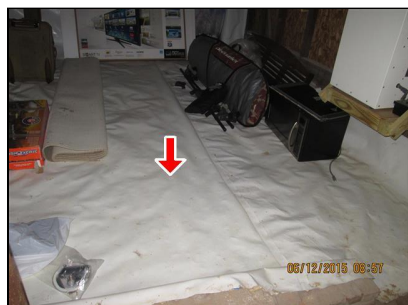
1.17 Picture 1 Vapor barrier present. Great work!

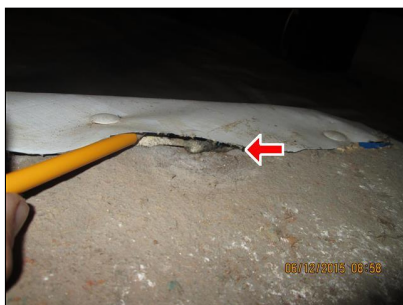
However, the perimeter of the vapor barrier is poorly sealed and unsealed entirely in some parts, allowing moisture to enter the crawlspace.(Picture 2)

1.17 Picture 2 Poorly sealed vapor barrier, allowing moisture in crawlspace

We recommend sealing the perimeter of the vapor barrier with 2" closed cell sprayfoam. This will ensure there is a firm, moisture-resistant seal between the barrier and all surfaces that will not degrade.

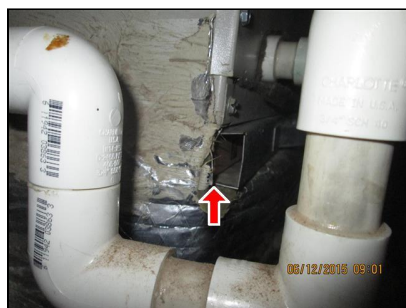
1.18 Picture 4 A poor fit for the basement system filter door

The best solution for the leaky filter door is to install higher quality, air-sealing filter door.

An alternate option would be to seal the filter door area with HVAC foil tape and replace this seal when changing the filter.

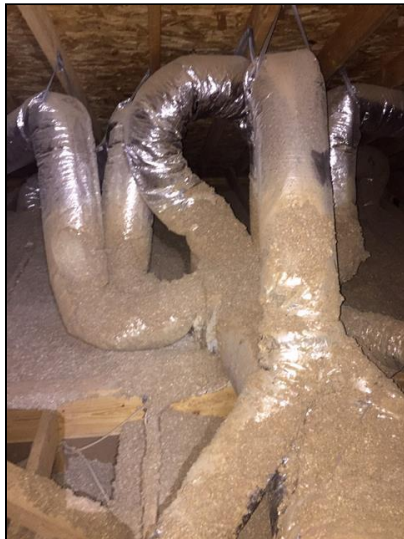
The 1st floor ductwork is excessive and reminds us of Spaghetti Junction. Item 1(Picture) The plenum connection to the air handler (including insulation jacket) is poorly sealed and the plenum duct connections are not air sealed. (Picture 1) (Picture 2) (Picture 3) (Picture 4) We understand that since the time of the audit, you have had a Manual-D assessment performed for your ductwork, with necessary alterations to the ducts made, along with a full replacement of the 1st floor system. Like a soothsayer, you did exactly what we were going to recommend before we even said it!

1.19 Picture 1 Excessive attic ductwork

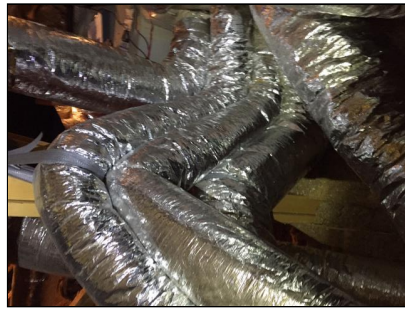
1.19 Picture 2 More excessive ductwork in the attic

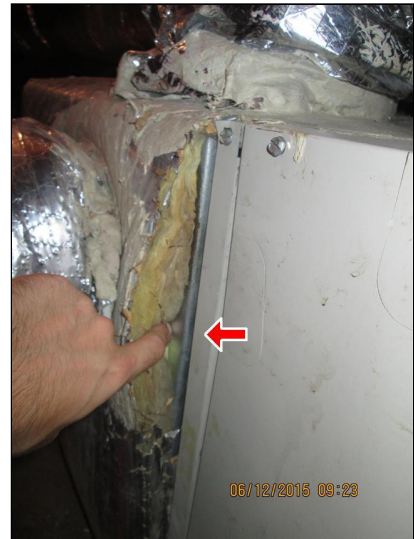
1.19 Picture 3 Insulation poorly attached to attic system plenum/air handler

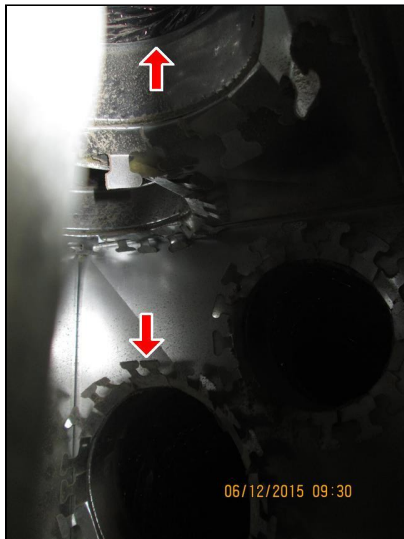
1.19 Picture 4 A view inside the attic system plenum shows no mastic was used to seal the collars

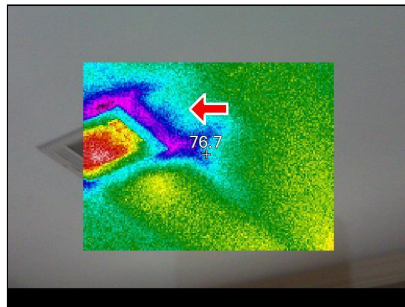
The registers throughout the home tested as leaky at the time of the audit. (Picture 5)

1.19 Picture 5 Registers throughout the home are leaky

We recommend sealing all register transitions in the home with foil tape and mastic.

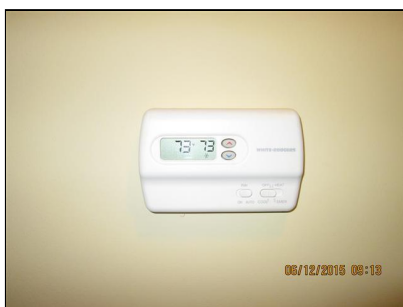
1.20 Picture 2 Basement system thermostat is not programmable

If you use the basement often and your schedule of doing so is consistent, we recommend installing a programmable thermostat for this floor.

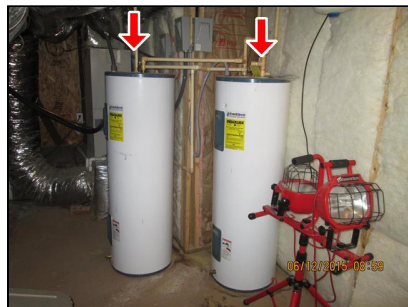
There are two water heaters supplying heated water to the home, both located in the unconditioned crawlspace. Both are standard efficiency electric water tanks, circa 2005 and in good operating condition. (Picture 1)

1.21 Picture 1 Water heaters in the unconditioned basement are uninsulated

We recommend insulating each of the water tanks with a 3" insulation blanket and insulating all accessible hot water lines to increase the efficiency of your hot water delivery system.

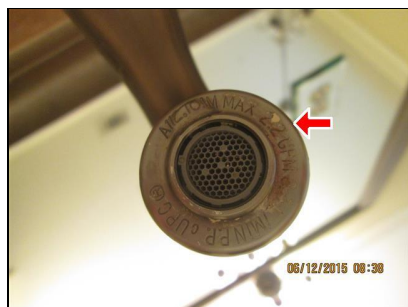
1.22 Picture 1 2.2gpm aerators throughout the home consume more hot water than low-flow aerators

We recommend upgrading all faucet aerators in the home to high-efficiency 1.5gpm aerators.
